Manhole Inspection Summary

Manhole # S21C__018MH

Insp Date: **9/19/07 10:38 AM**

Location Address: **1700 MOUNT ST** Cross Street: **MULBERRY ST**

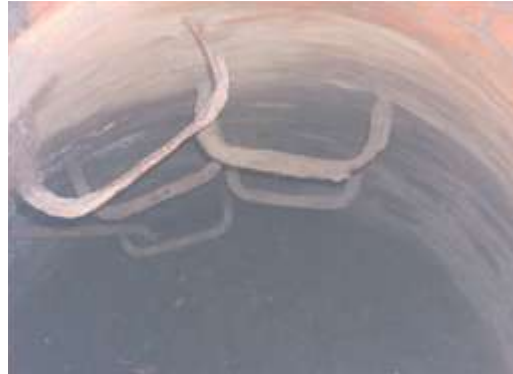
Defect 2

Steps Count: **5** Missing: **0** ☒ **Corroded**

CORRODED STEPS

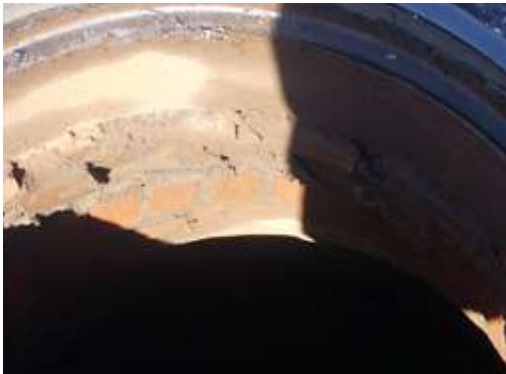
Defect 1

Chimney / Frame Adjustment ☒ Exists Material: **Brick** ☐ Parged Height: **9** (in.)
Condition: ☐ Sound ☐ Cracked ☐ Root Intrusion ☒ **Loose Brick** ☒ **Deteriorated**
Infiltration: ☒ None ☐ Joint ☐ Cracks ☐ Mortar ☐ Roots ☐ Wall

CHIMNEY DETERIORATION

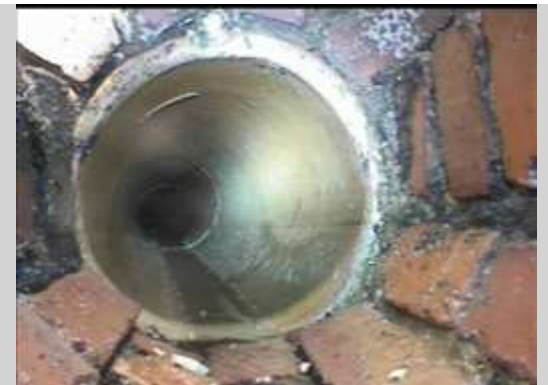
9 O'Clock Inflow

Pipe Height: **8.4** (in.) Rod and Bar (Angled)
Pipe Material: **Clay** ☐ Pipe Lined
Invert Depth: **10.65** (ft.) Flow Characteristics: **None**
Deposits: ☐ None ☐ Mud ☐ Sludge ☒ **Debris** ☐ Grease
Silt Depth: **1** (in.) Deposits Extent: **Light**
Infiltration: **None** Pipe Seal Cond: **Sound**
